WIND AND HAIL DAMAGE TO ASPHALT SHINGLES IN IOWA

Major Subject: Agricultural Engineering
(Farm Structures)

Iowa State College
1948

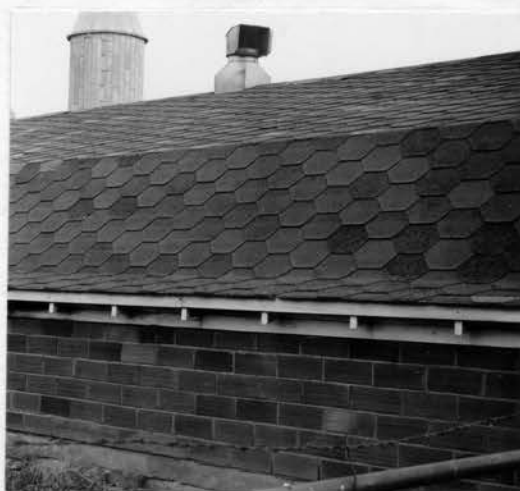
Fig. 16. Weathering Due
to Different Slopes

The average slope of a good roof was 34° . The extremes were from a minimum of 20° to a maximum of 60° . The roofs with the least slope weather the faster due to the action of the sun. There were but two roofs with less than 30° slope and these were both heavily shaded by trees. The steeper sloped roofs will give longer service if the sun is the only factor in causing a roof to wear. Figure 16 will show evidence of this fact.

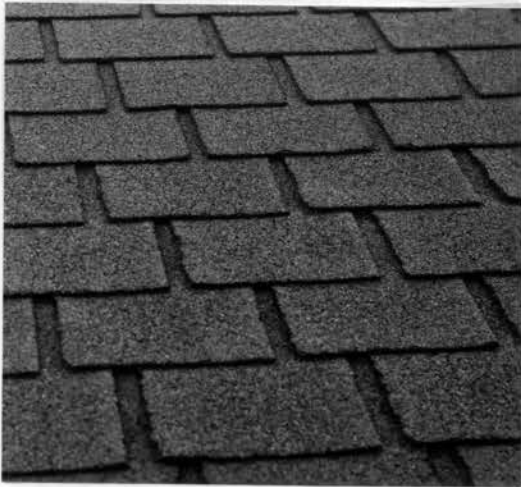
Fig. 21. North Slope of
a 28 Year Old Roof

directly exposed to the sun. This can be shown by the evidence of Figure 21 in comparison to Figure 22. In like manner, other buildings were of benefit in protecting the asphalt shingle roofs. Protection for buildings is shown graphically in Figure 14. Windbreaks and other buildings were found in 86 percent of the cases investigated, whereas in 14 percent of the cases there was no protection for good asphalt shingle roofs.

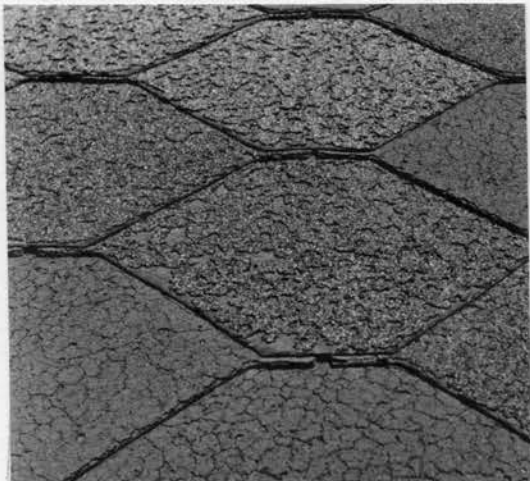
Fig. 28. Even Weathering

Asphalt shingles varied in thickness from 0.120 inches to 0.250 inches with the average thickness of 0.174 inches as shown in Figure 27. Shingles wear out and decrease in thickness through the years. Some shingles wear out uniformly as shown in Figure 28, whereas other shingles do not and come off in small sections as shown in Figure 24. The average thickness of the good shingles after 22 years service is 0.022 inch greater than the average new shingles now commonly sold.

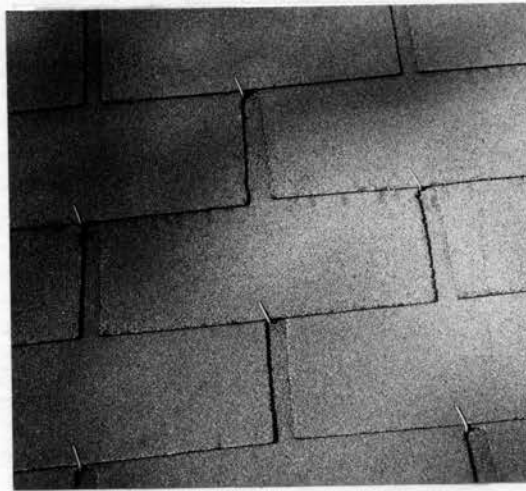
Fig. 68. A Two Year Old
Clipped Roof

Clips have been another means of fastening tabs down so that wind cannot blow them away. Figures 68 and 29 show two different shingles that have been clipped. Figure 68 has been clipped for one year and Figure 29 has been clipped for ten years. The clip can be used equally well on either a square butt or a hexagonal asphalt shingle. All roofs that have been examined have given excellent service. This type clip does not cut the asphalt shingle through as does a staple. There is no evidence of damage to the tab as shown in Figure 29. For either new construction or repair work this type of fastener is also recommended by the author.
